Non-Union Humeral Shaft Fracture with Hardware Failure

Molly Hovendick, MAT, ATC, LAT., Northeastern State University

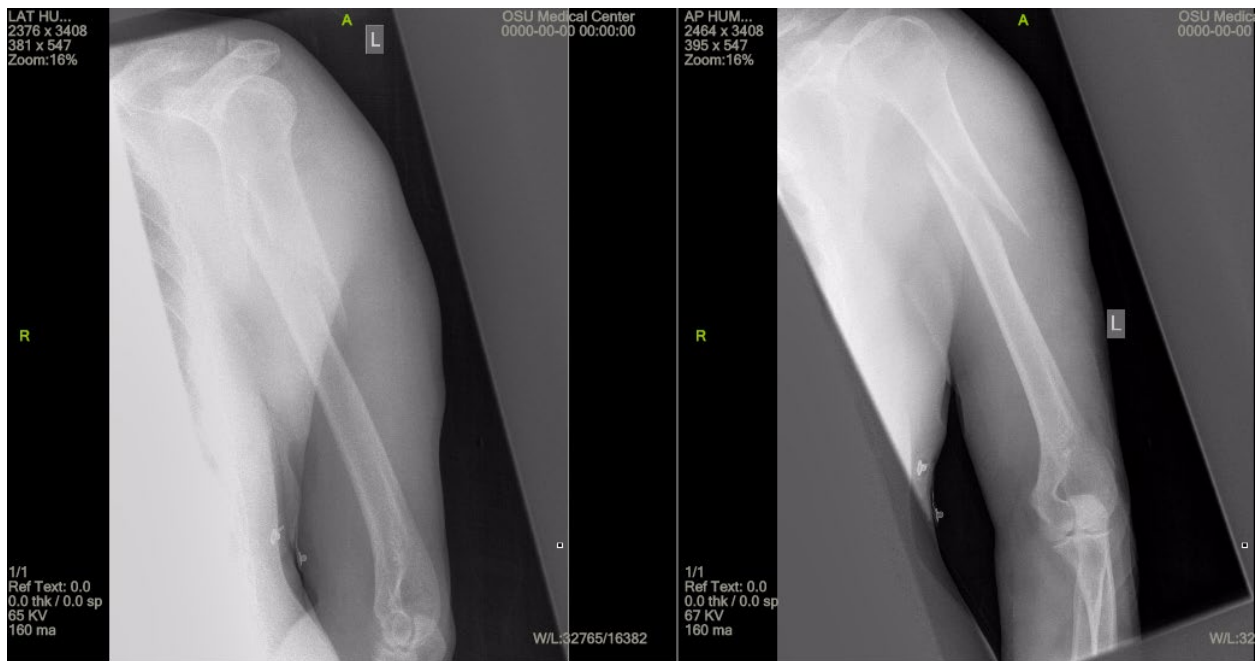
Image 1 demonstrating a proximal $\frac{1}{3}$ meta-diaphyseal humerus fracture

The patient is a right hand dominant 66 year old male with a history of inflammatory osteoarthritis anxiety, tobacco use, and regular alcohol use. He presented to the emergency department with left arm pain and disability due to a fall from standing height. Initial radiographs were obtained demonstrating a proximal $\frac{1}{3}$ meta-diaphyseal humerus fracture (image 1). He was placed in a coaptation splint and referred to an orthopedic surgeon for consultation.

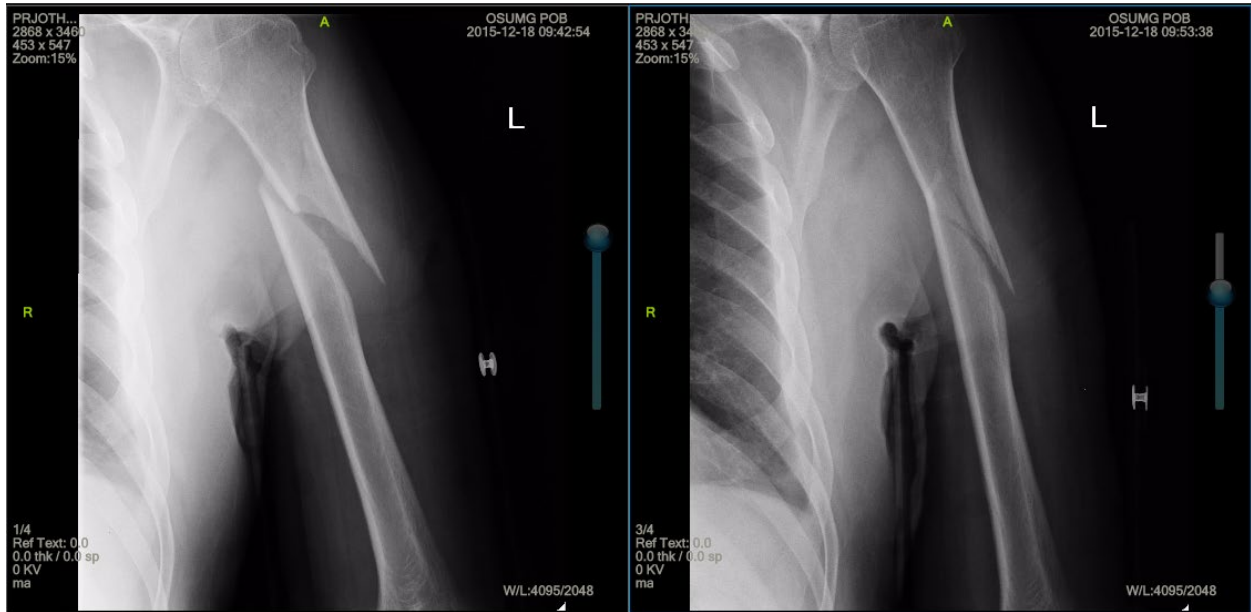
Image 2 indicating fracture displacement following one month of conservative bracing

At his second follow up visit approximately one month later, he reported continued pain and discomfort in his upper extremity. He reported pain associated with the brace and therefore removed it against medical advice. Repeat imaging confirmed further displacement of the fracture without signs of bone healing (Image 2). The patient elected to proceed with open reduction internal fixation (ORIF) on the following day. The fracture was reduced with a rigid, locking plate construct and no interfragmentary compression or fixation (image 3).

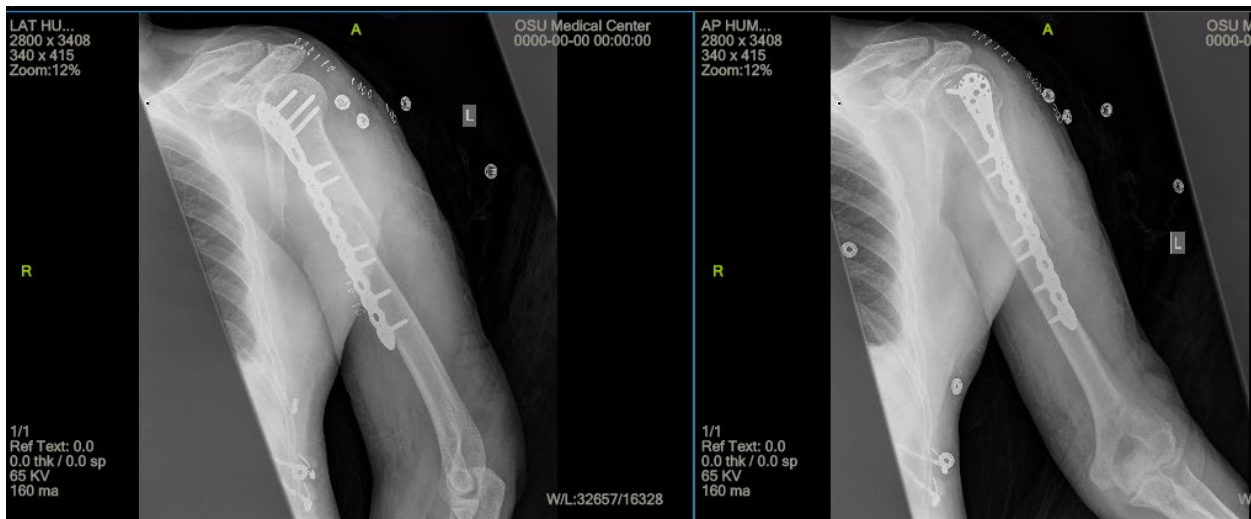
Image 3 post ORIF surgery to remove failed hardware and secure fracture site

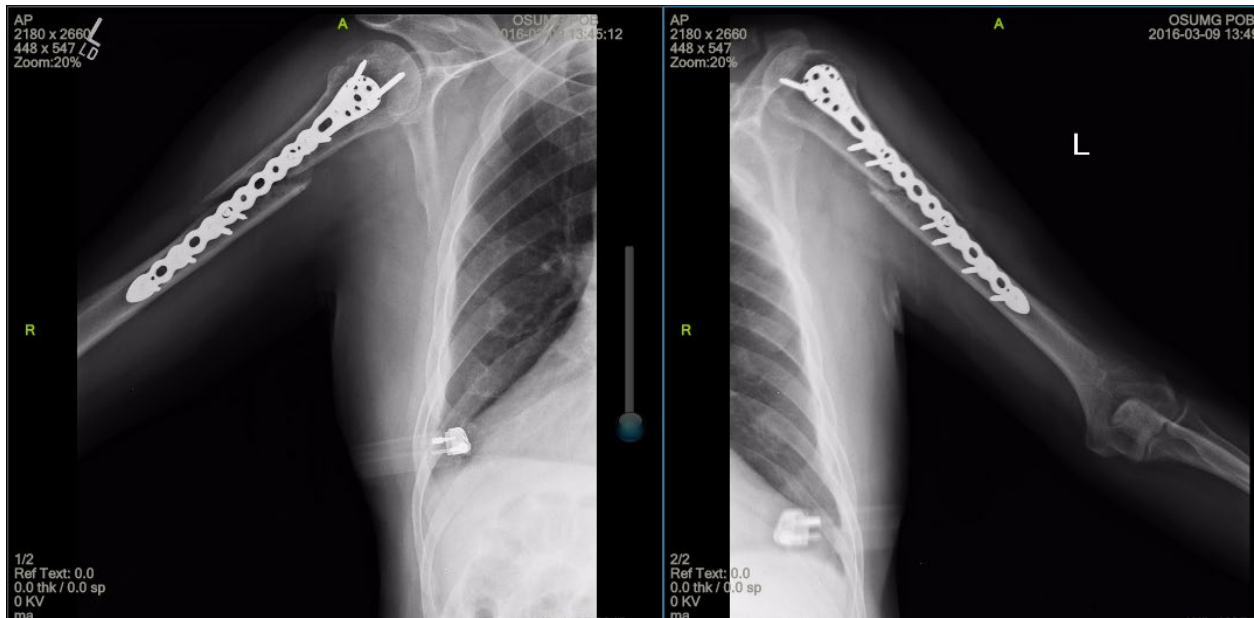
Image 4 showing minimal callus formation at 5 months post-surgery

The patient returned 3 weeks post-surgery and complained of pain with forward flexion and abduction of left shoulder. At that time there was no evidence of callus formation, but the fracture alignment was well maintained with plates and screws. The patient followed up eight weeks post-surgery without change in radiographic appearance from initial post revision radiograph. There was concern of a possible delayed union due to cigarette smoking⁷⁻⁹ and possible noncompliance with post-operative restrictions. Smoking cessation was discussed, and a bone stimulator was ordered to promote fracture healing. The patient returned again 3 months post-surgery with no change at the fracture site. The patient was instructed to wear the bone stimulator for 2 months at which time follow up films were ordered. Smoking cessation was discussed again at this time.

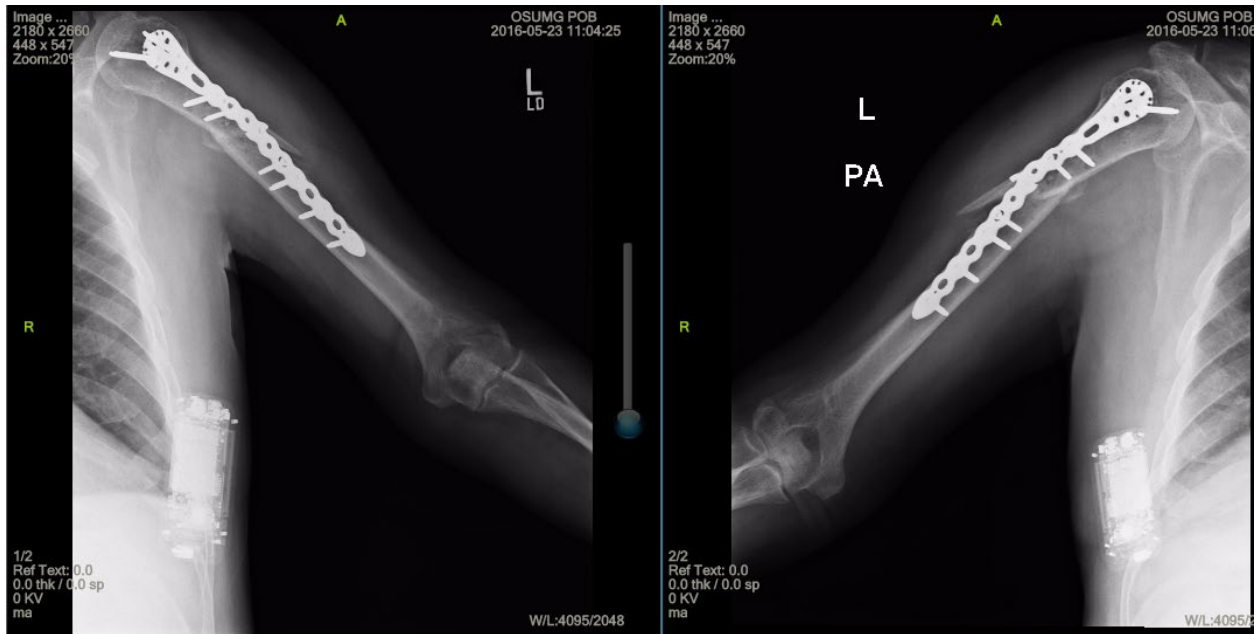
Image 5 indicating non-union fracture and hardware failure

The patient returned for an office visit two months later reporting that he fell the previous weekend while at home and was unable to independently move his left arm. Imaging showed a nonunion of the original humeral shaft fracture and gross hardware failure (images 5 and 6). After further discussion with the patient about the possible long term complications, we decided to perform the ORIF revision.

The patient returned and he reported that he had been using the bone stimulator but continued to smoke. He also reported a recent fall reinjuring his left shoulder while mowing his lawn. He stated that prior to his fall he had unrestricted use of the left arm. The radiographs again demonstrated minimal callus formation in left humerus. It was also observed that there was now joint malalignment with signs of hardware failure through the locking plate. A revision ORIF procedure of the humerus with bone graft was discussed with patient, however he did not follow up for the planned procedure.

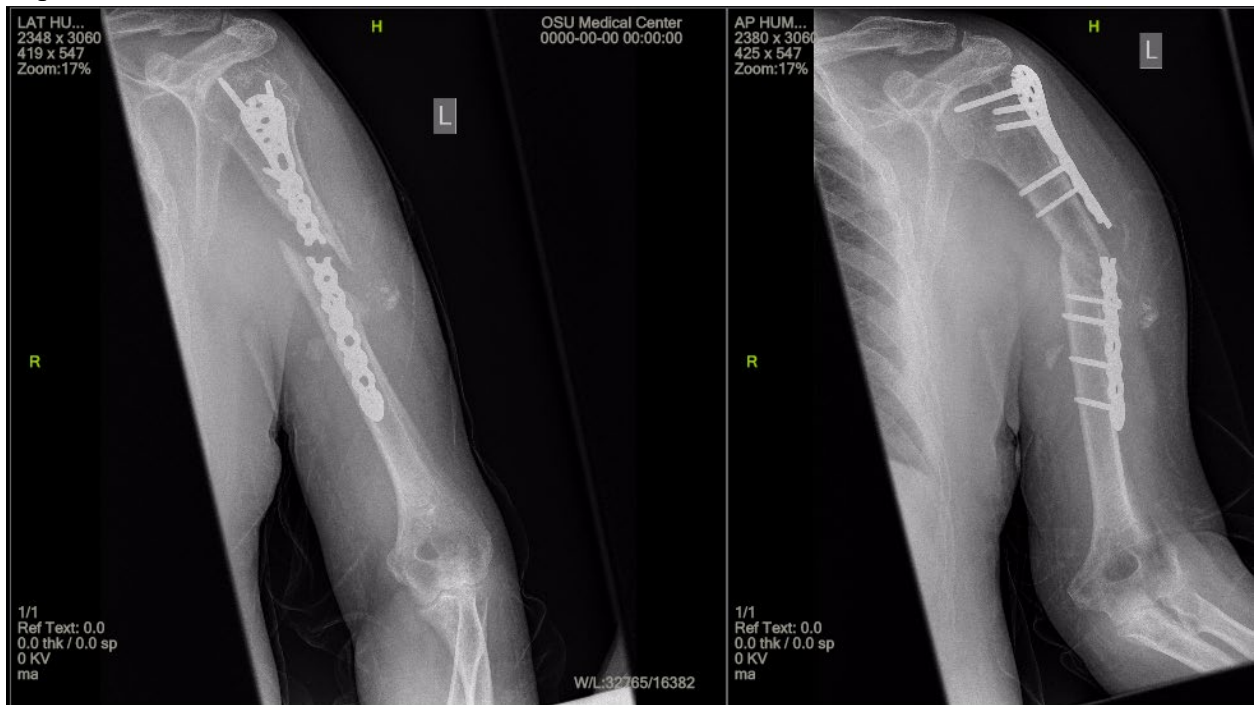
Image 6 indicating non-union fracture and hardware failure

One week later, the patient underwent hardware removal with revision ORIF with lag screw fixation and compression plating. He was immobilized and made non weight bearing to the operative extremity. He was discharged home the following day once his surgical drain was removed.

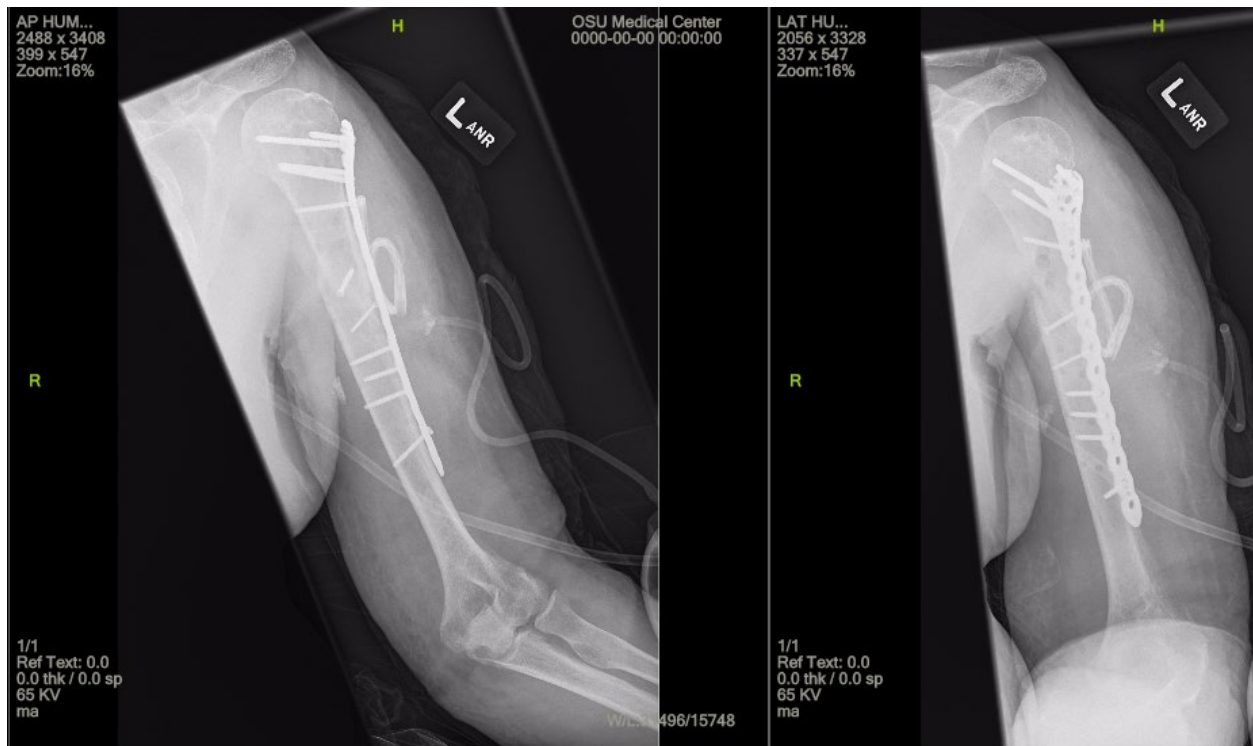
Image 7 post revision ORIF showing new hardware fixation

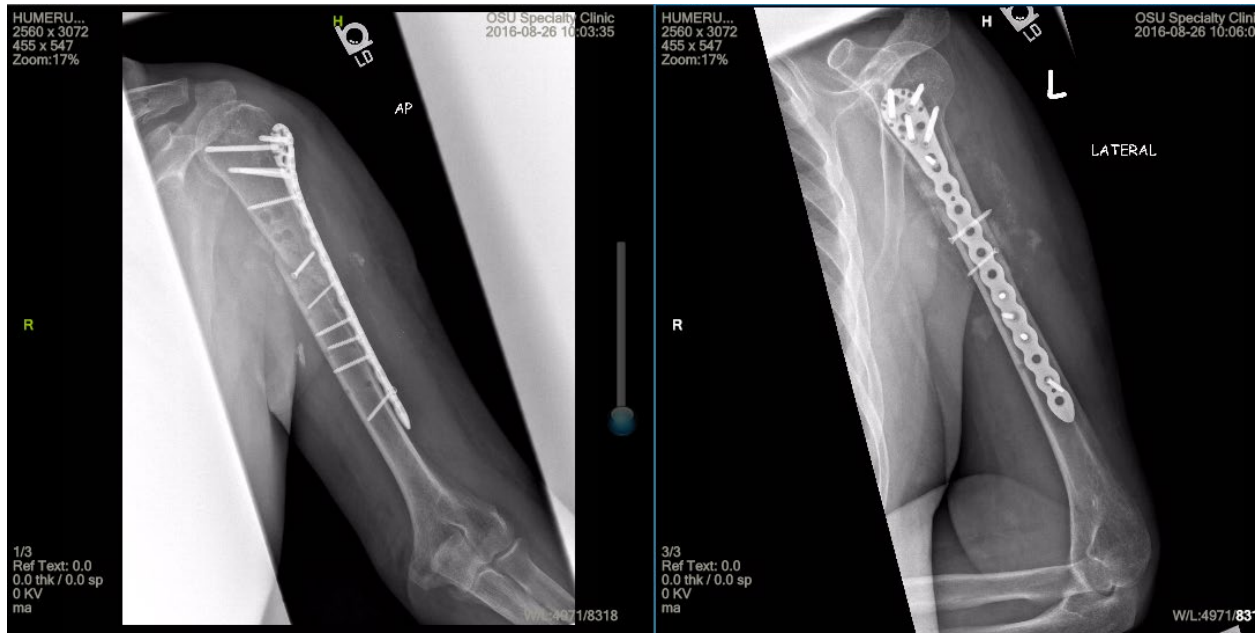
Image 7 showing humeral alignment and hardware setting

The patient returned approximately four months later and imaging revealed continued fracture alignment (Image 7). The patient was instructed to continue the use of the bone stimulator and was transitioned to outpatient physical therapy. The patient also reported cessation of smoking and alcohol use at this time.

During the patient's post-operative visit approximately three weeks later he still demonstrated diminished range of motion. The radiographs showed no active callus formation however the hardware plate and screws maintained good position. The patient indicates that he decreased smoking to one-third pack per day as well as using smoking cessation supplements and drinks two glasses of wine nightly. The patient was instructed to restrict use of the left shoulder but cleared for full range of motion for elbow and wrist. The patient was to perform range of motion exercises several times per day and to apply the bone stimulator to fracture site daily. One month later imaging showed continued true anatomic alignment of the humerus. The patient also reported that pain in the humerus decreased and range of motion was increasing. The patient was instructed to continue the use of the bone stimulator and referred on to physical therapy for range
